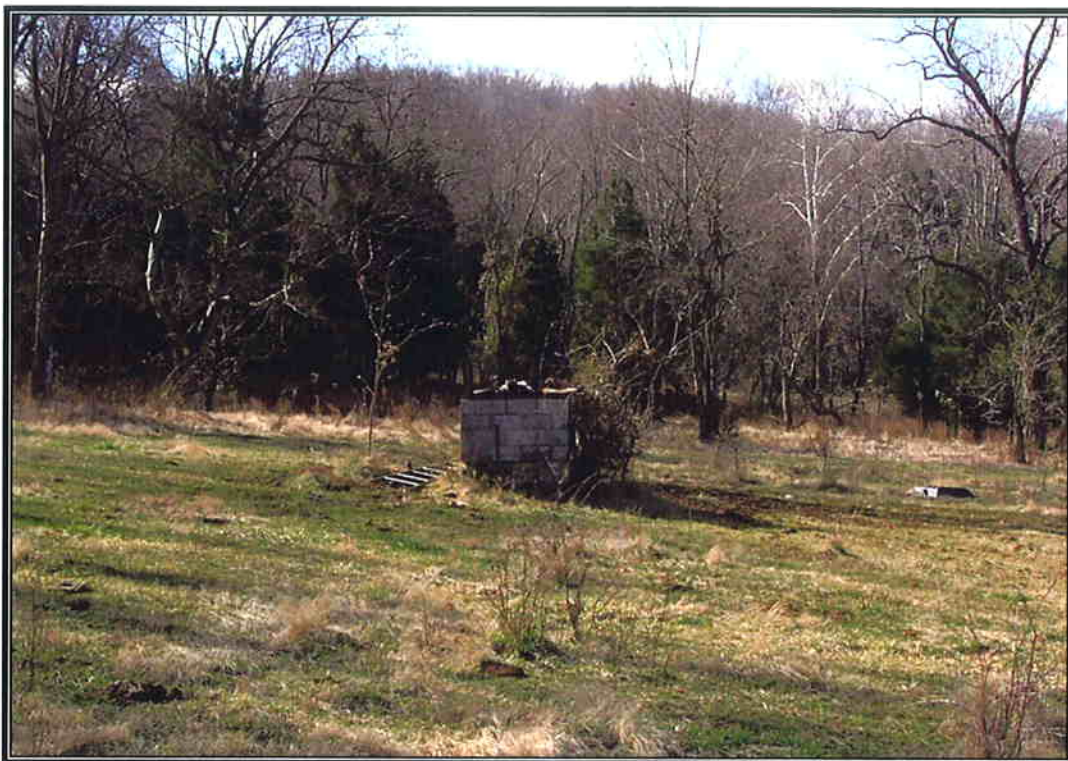
Figure 53. Site 3, Concrete block outbuilding (Resource F), possibly a well pump house.

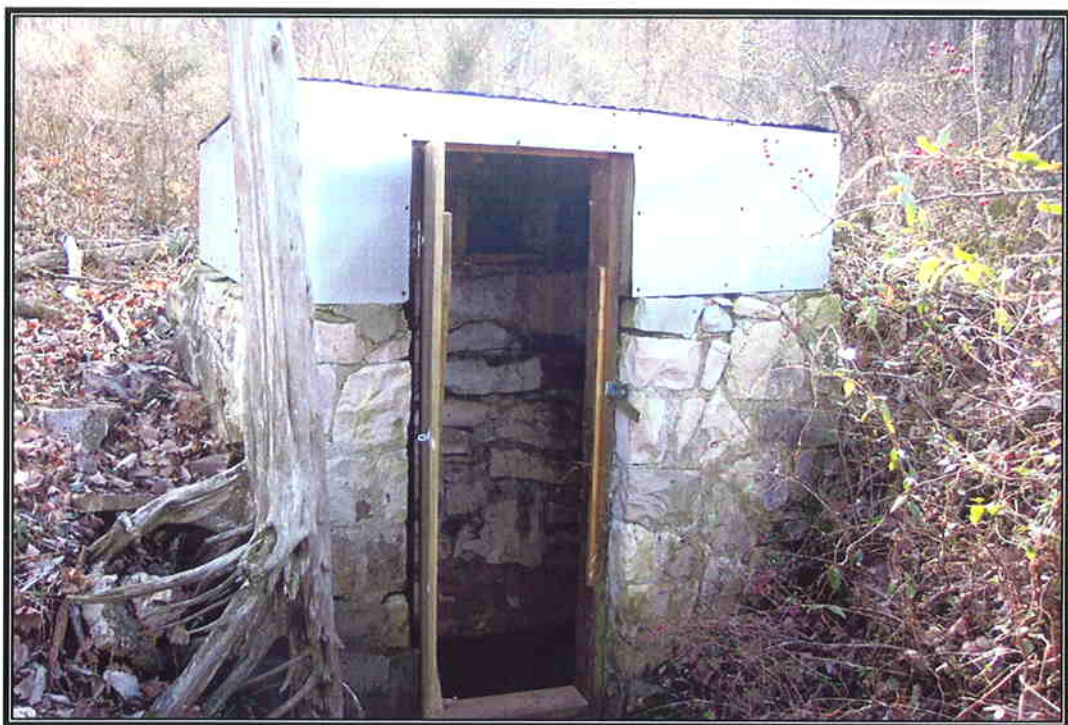
Figure 54. Site 3, Stone springhouse with raised roof (Resource G).

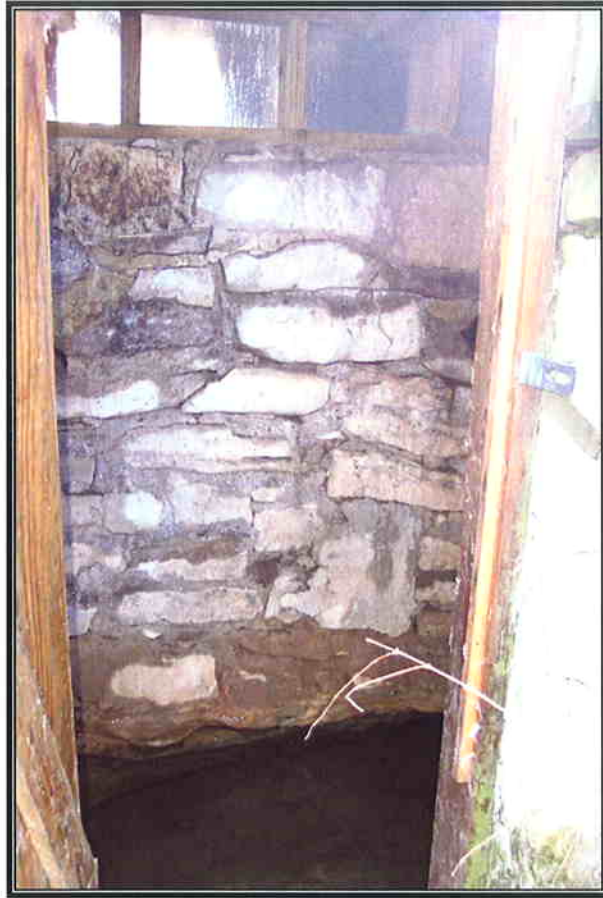
Figure 55. Site 3, Interior of stone springhouse.

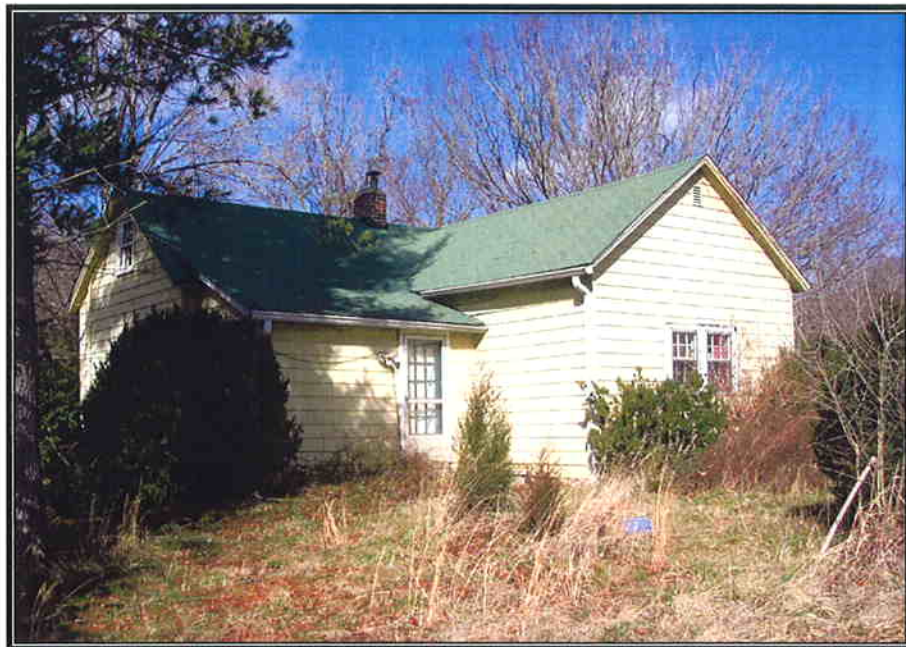
Figure 56. Site 3, Façade and southwest elevations of secondary residence (Resource H).

The northeast gable end of the original portion of the house has a window along the main floor and a second window near the apex of the gable. The southwest elevation of the house has paired windows and a window near the apex of the gable (Figure 58). A single-leaf entry is found on the rear elevation of the house. A brick chimney pierces the ridgeline of the original portion of the house. The roof is sheathed in asphalt shingles. The house is clad in aluminum siding that almost extends to grade. A stone foundation is visible along portions of the house. Yeager states that a log house was located at the terminus of Keystone Road in 1977. Yeager also states that the property was known as the “Thompson-Perkins Lodge” (Yeager 1977:74). Yeager may be describing this secondary residence. A shed-roof frame outbuilding that is in near ruinous condition is located to the rear of the tenant house. The outbuilding is partially clad in vertical boards and portions of the roof are sheathed in prefabricated metal panels.

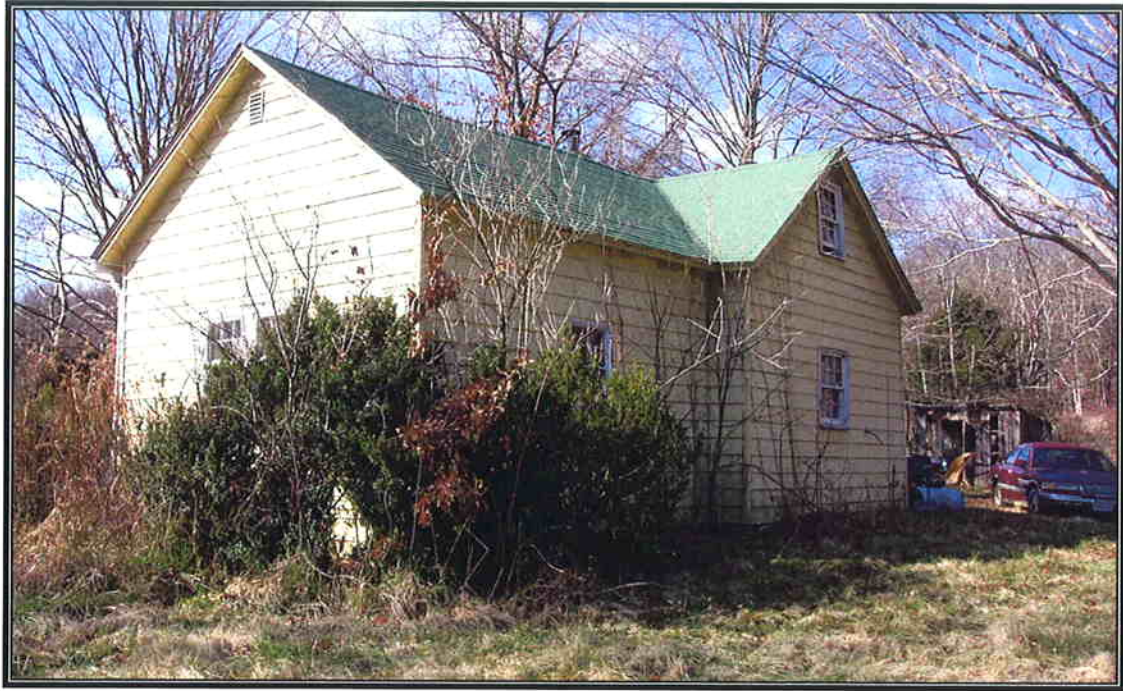
**Figure 57. Site 3, Façade and northeast elevations of secondary residence.**

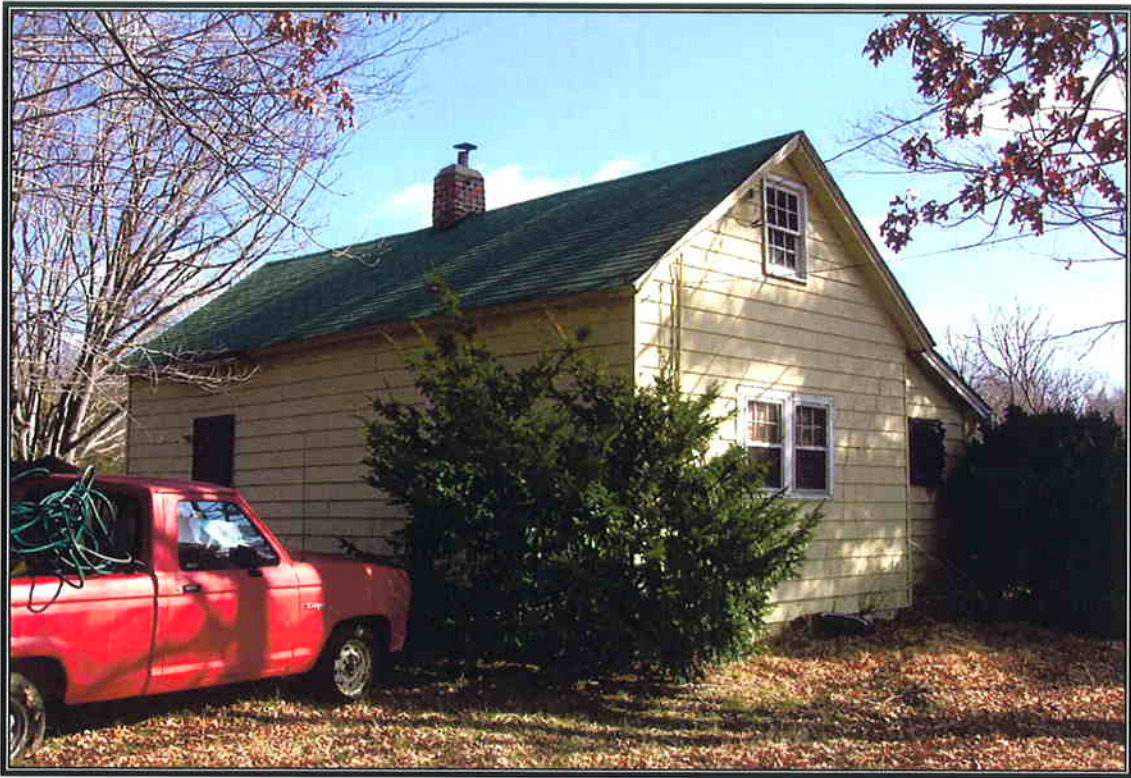
Figure 58. Site 3, Southwest and rear elevations of secondary residence.

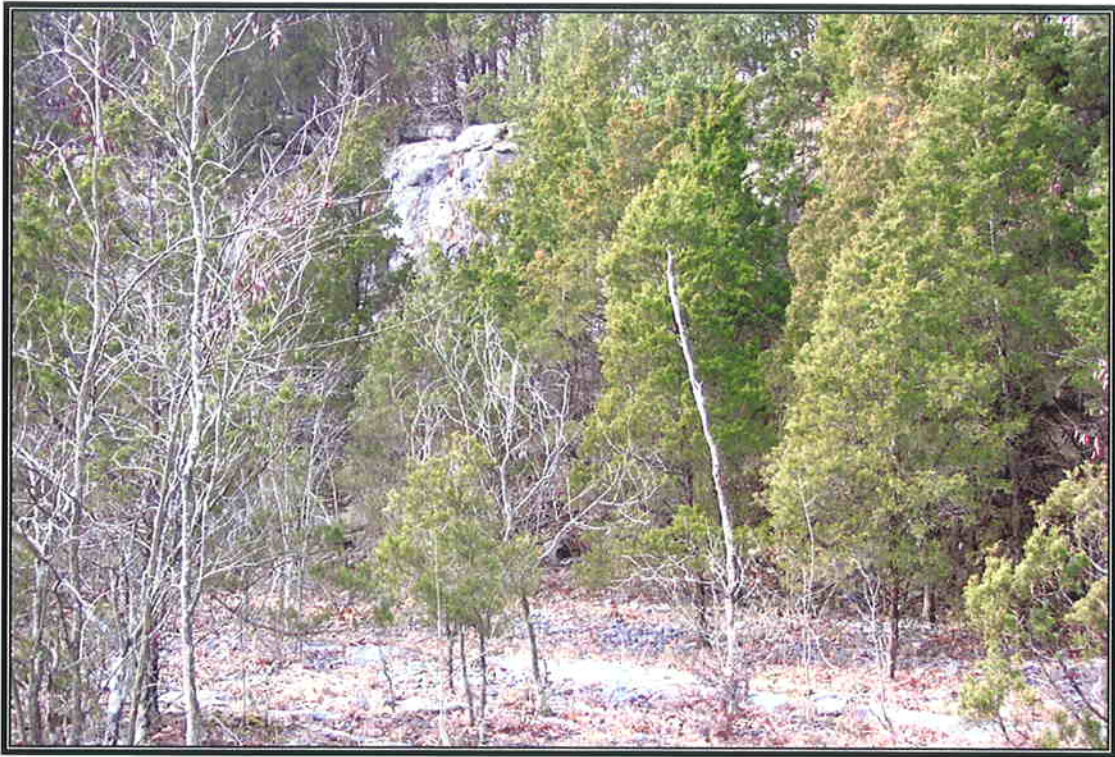
**Figure 61. Site 3, View in quarry (Resource I) to vertical wall.**

The large quarry, which is surmised to be the Keystone Quarry, may be eligible as a historical industrial archaeological resource under Criterion D. No standing structures are associated with the quarry. An archaeological investigation of the quarry may be able to provide information on quarrying methods and a context for Warren County stone quarries.

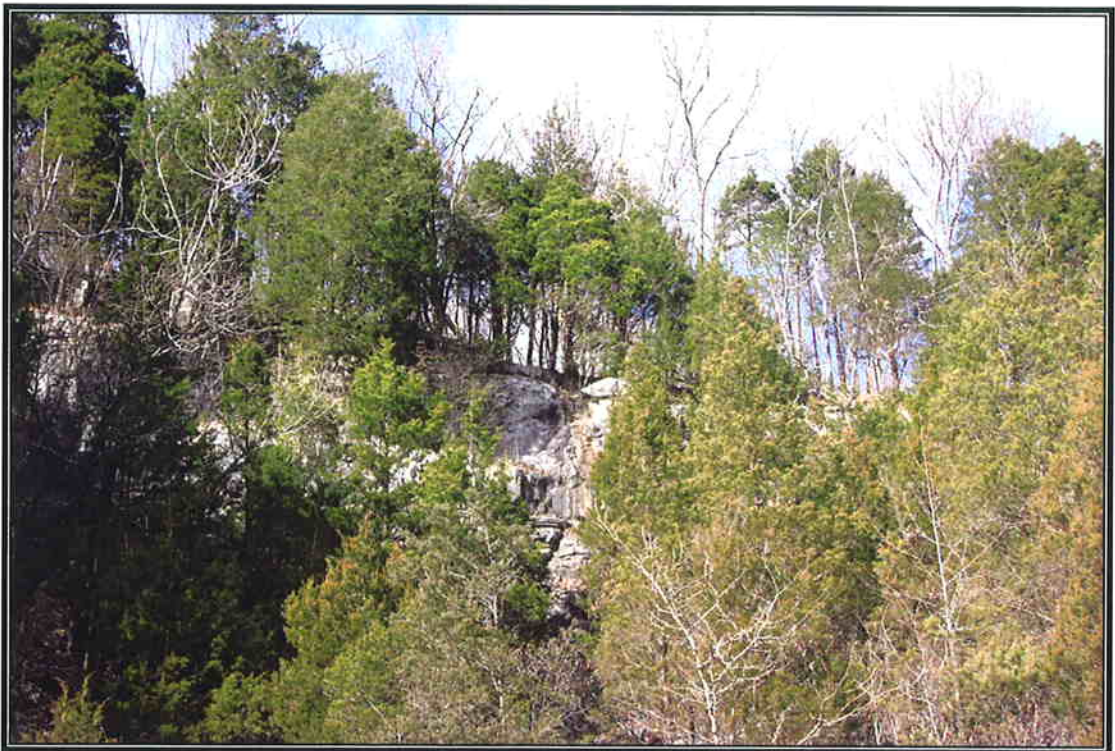
**Figure 62. Site 3, View in quarry to vertical wall.**

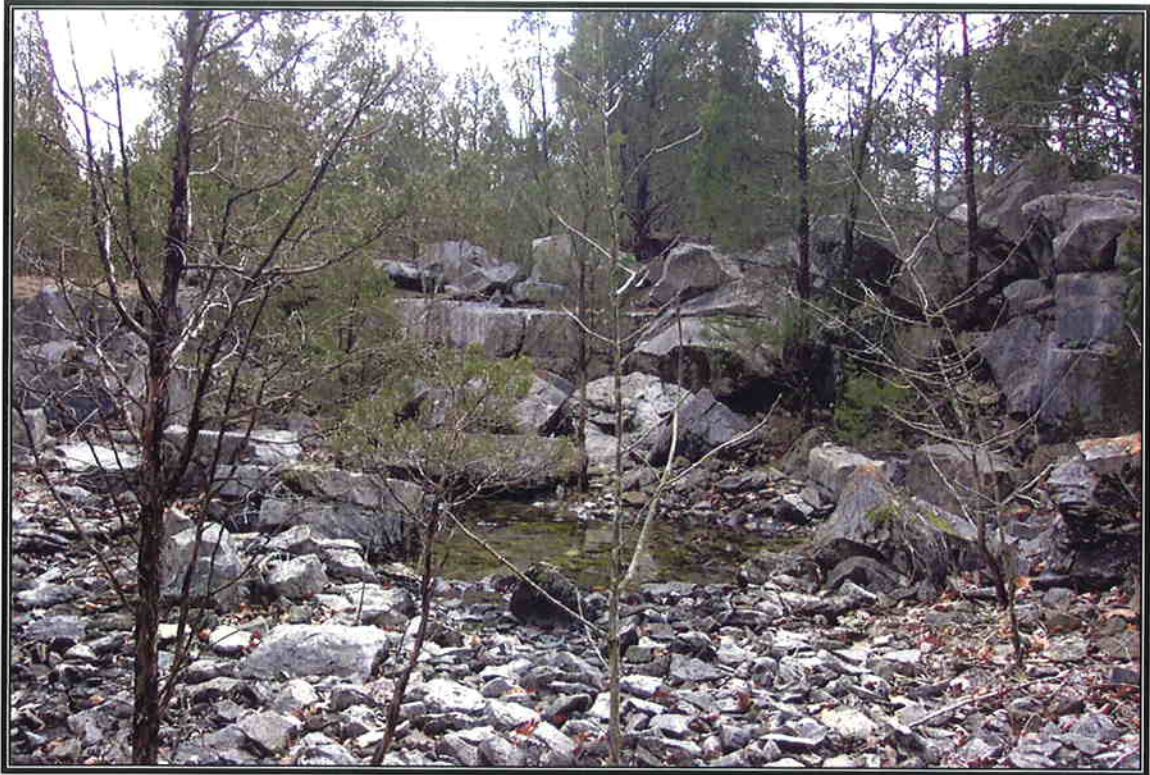
Figure 63. Site 3, View near the southern portion of the quarry.

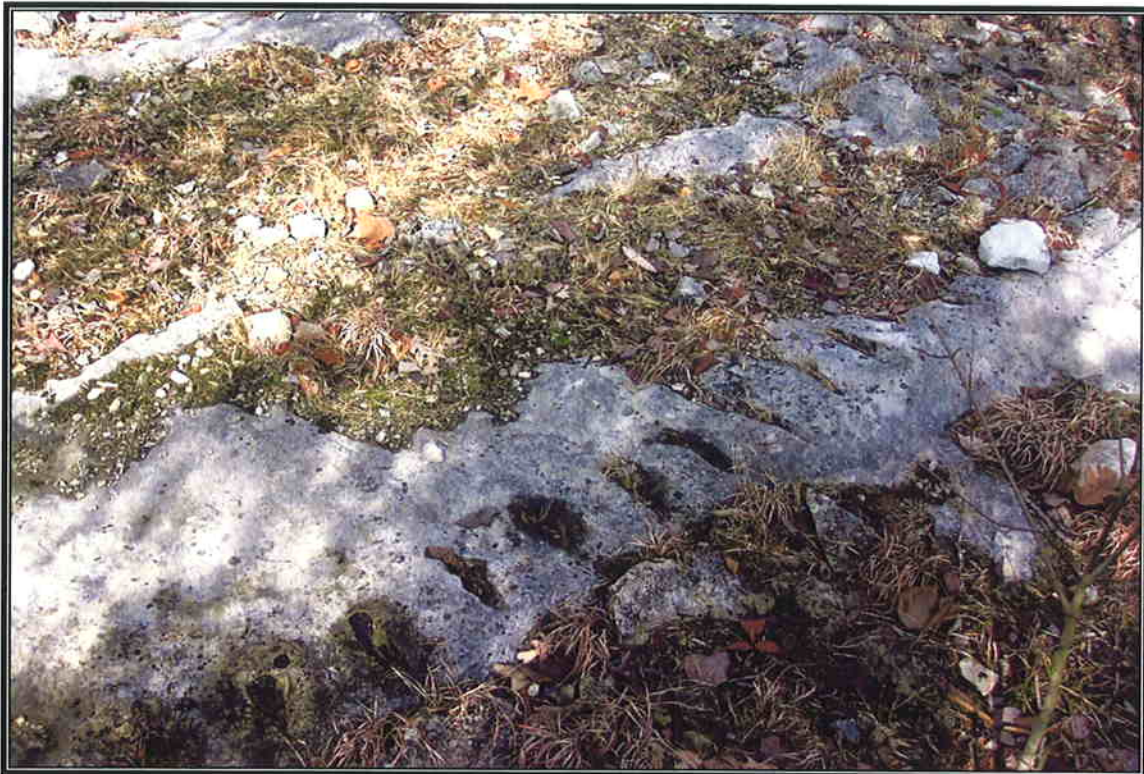
The former quarry road may be indicated on the 1928 oil and gas map (Figure 24) but is not shown on the 1952 topographic map (Figure 25). A second road to the quarry is illustrated on 1928 oil and gas map and the 1952 and current topographic maps (Figures 24, 25, and 2). The portion of the road extending through the woods toward the quarry is rutted in places and pieces of stone from the quarry are found to either side of the former road (Figure 60). The former road intersects another road that is in better condition. This road leads past the quarry to a water tank currently in use that is located to the southwest of the quarry. The quarry itself has a vertical wall along the west side that appears to be 15 feet or more in height (Figures 61 and 62). Near the southern end of the quarry are large and irregular stones, probably waste material (Figure 63). A large portion of the quarry floor is relatively flat, with exposed stone on the surface. Examples of quarrying methods are easily visible, including drill holes for the placement of wedges to split the stone away from the ledge (Figure 64), the remains of long horizontal cuts in the rock (Figure 65), and the base possibly for a piece of equipment (Figure 66).

Figure 64. Site 3, Drill holes visible in quarry.

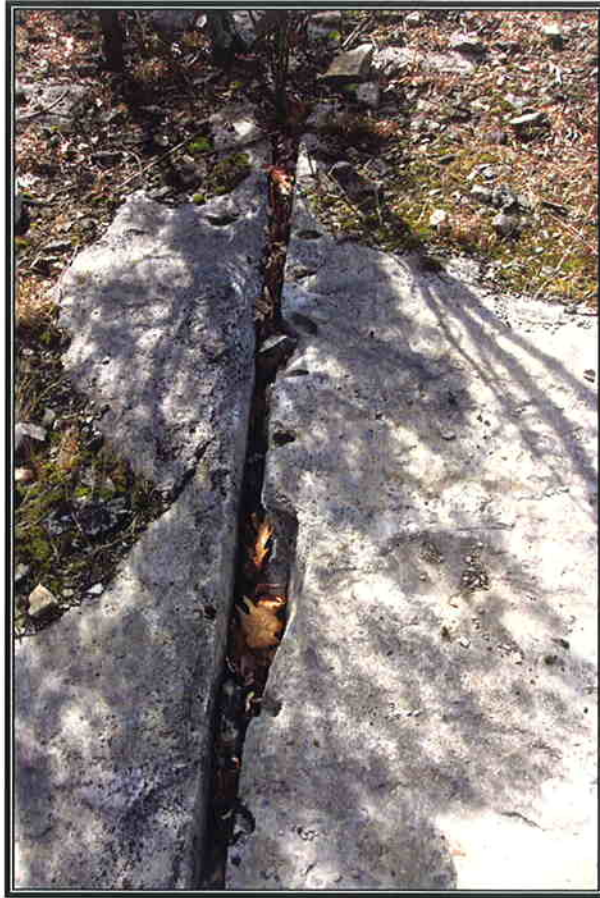
Figure 65. Site 3, Horizontal cuts visible in quarry.

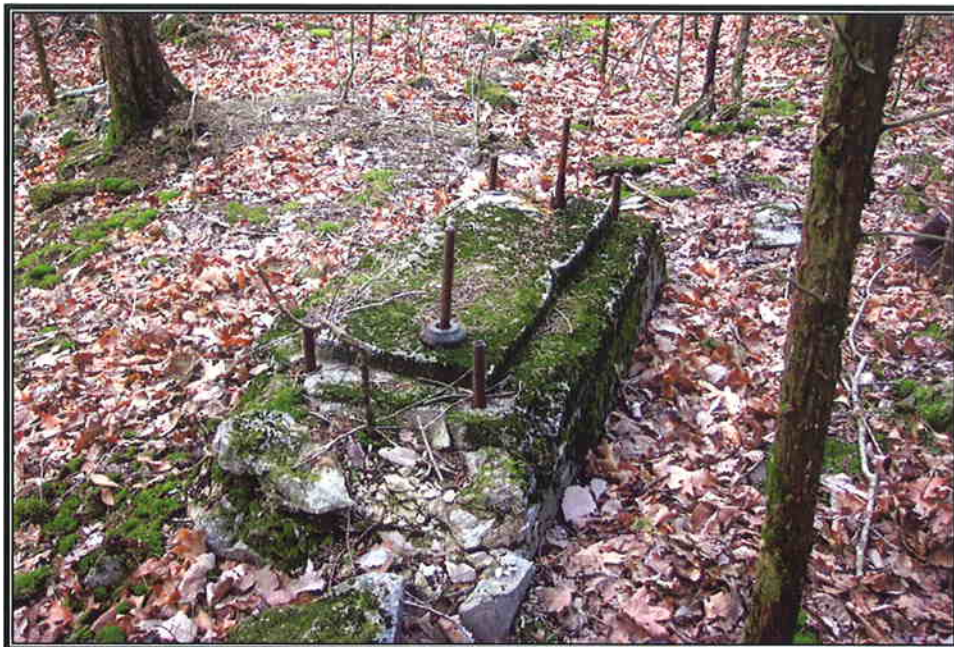
Figure 66. Site 3, Remains of possible base for equipment in quarry.

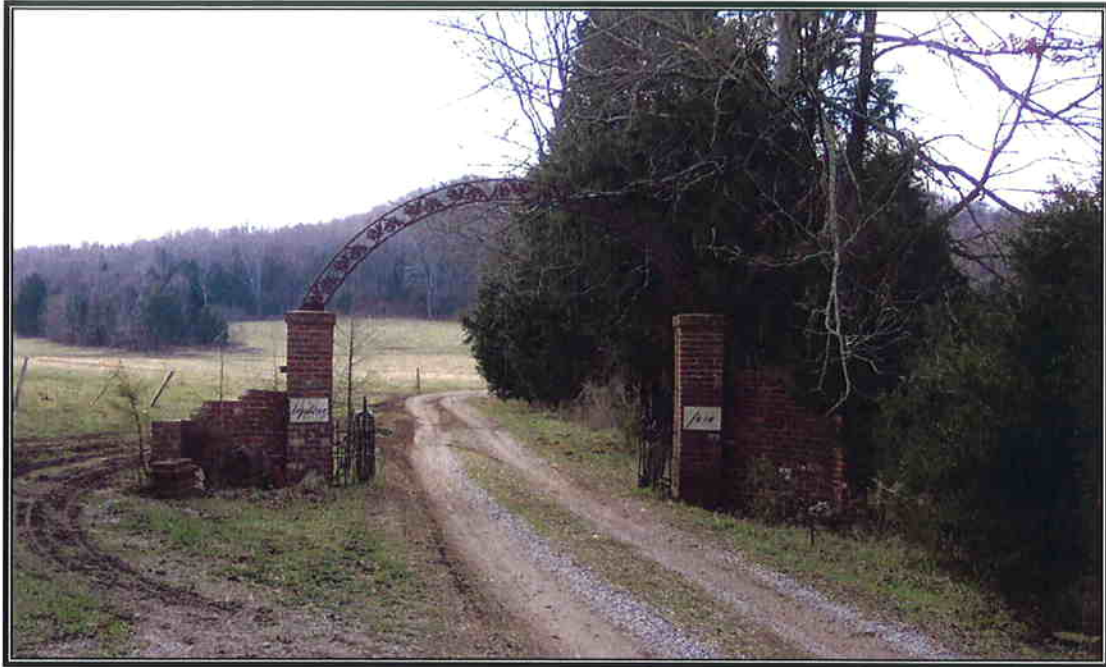
off L. C. Carr Road (Resource K) (Figure 67). Historic metal gate posts, possibly brought to the site at the time of the additions to the main residence, are attached to the interior of the gate posts. Attached to the gateposts are plaques stating "Keystone Farm." The entry was probably constructed in the 1960s at the same time as the additions to the main house. In the left portion of the figure is the projection of the woods indicating the historic quarry road described above.

Figure 67. Site 3, Brick entry posts onto Keystone Farm (Resource K).

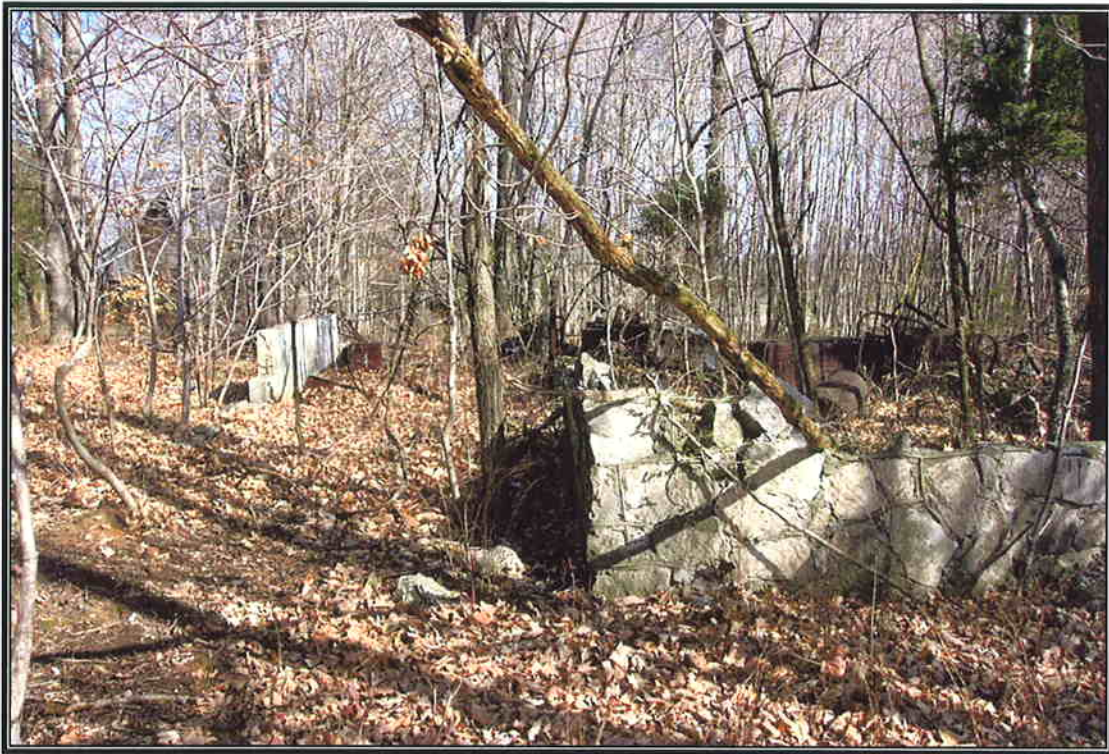
The current owners of the site also own adjacent property that extends to US 68 (Russellville Road). Located at the end of a long drive is a stone foundation of a former house (Resource L) (Figure 68). The mortared rubble stone foundation has grapevine mortar joints. Poured concrete steps are found along the front of the house. Beside the steps is a large metal casement window that accommodated 20 lights. Sharp stated during the survey that the house burned in the late 1960s or early 1970s. A well purportedly was located to the front of the house, although only scattered lumber on the ground indicates its location. Located to the rear of the house are the walls of a former garage (Figure 69).

Figure 68. Site 3, Southwest and rear elevations of foundation of former house (Resource L).

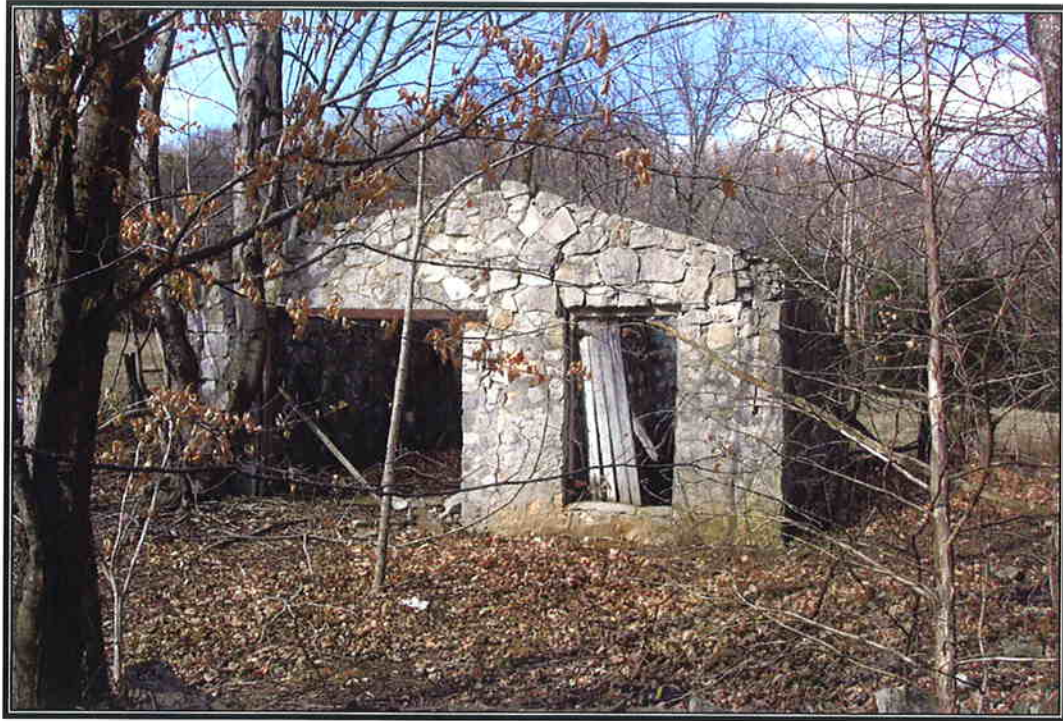
**Figure 69. Site 3, Stone walls of former garage.**

The garage and former house were oriented to the southeast. The garage walls are of mortared rubble stone construction. The garage entry to the left has a steel lintel. A pedestrian entry is located to the right. The floor of the pedestrian side has a stone-lined trench located in the floor (Figure 70). It is unclear what purpose this room or trench served. A vertical joint on the rear elevation of the garage indicates one side was possibly an addition (Figure 71). The construction methods of the garage and house foundation as well as the metal casement window frame suggest the house was constructed in the first half of the twentieth century. There was speculation that the residence may be associated with the Keystone Quarry, but no evidence of this supposition was uncovered during research for this letter report. The remains of a shed-roof outbuilding of box-frame construction is located to the rear of the garage. The majority of two of the walls of the outbuilding have collapsed. Portions of the outbuilding's vertical board construction are clad in rolled asphalt in a brick pattern. Northeast of the foundation of the former

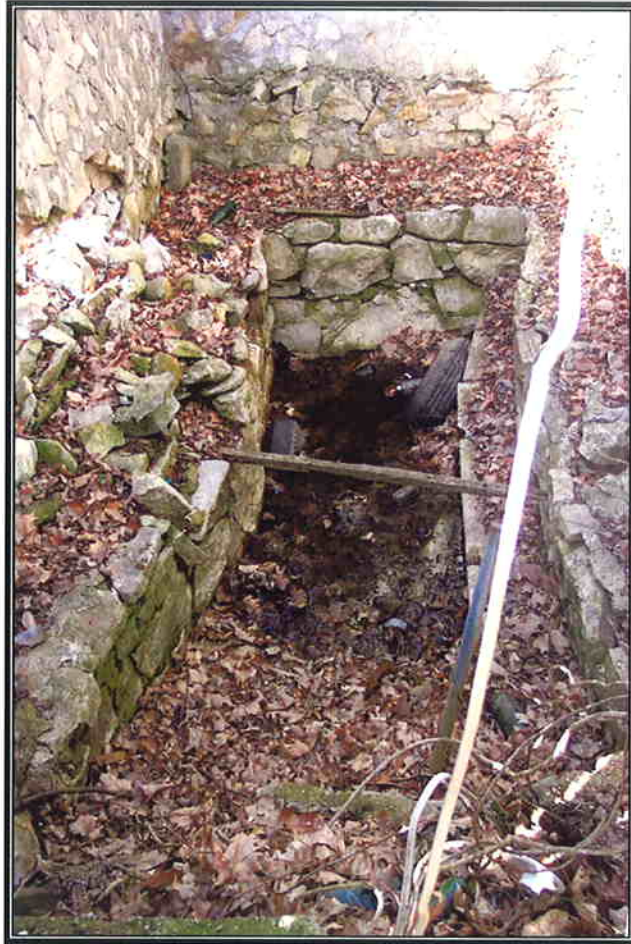
Figure 70. Site 3, Stone lined trench in northeast portion of garage.

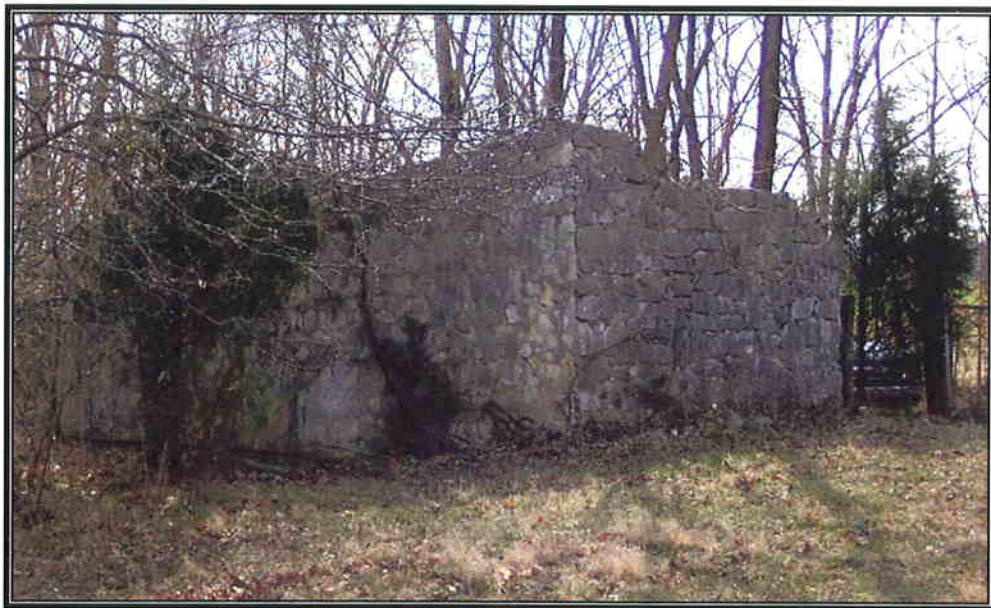
Figure 71. Site 3, Northeast and rear elevations of former garage.

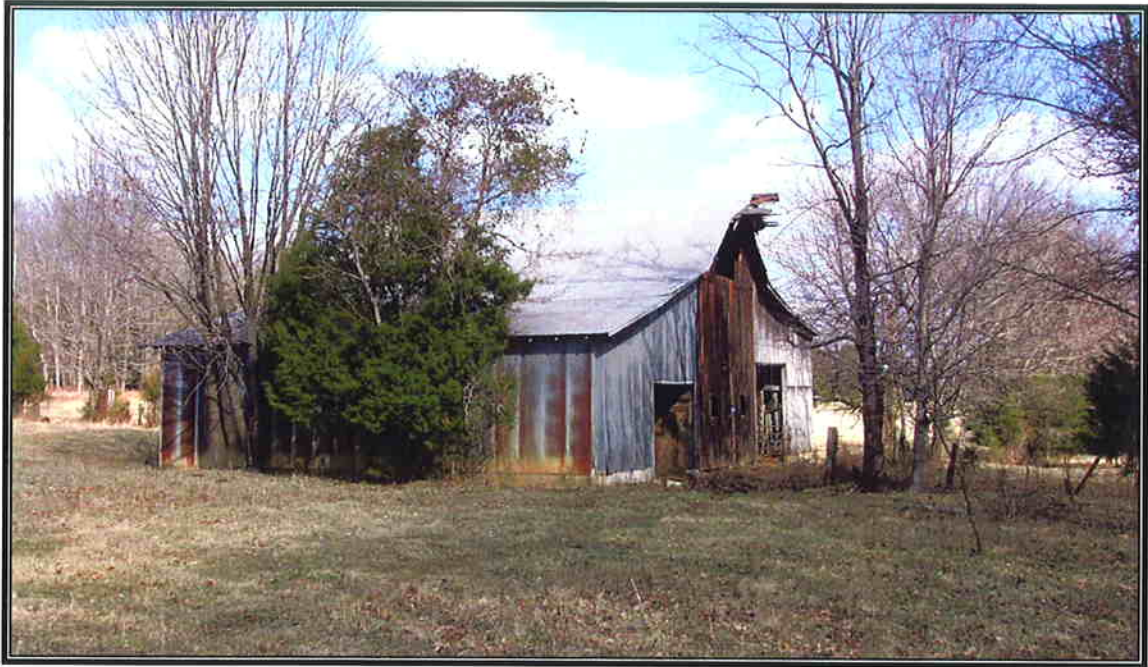
house is a frame livestock barn (Resource M) (Figure 72). The remains of a hay hood are visible along the southeast elevation of the barn. The barn is constructed of nailed sawn lumber (Figure 73). The roof is sheathed in prefabricated metal panels. The middle portion of the barn's roof has wood board sheathing under the prefabricated metal. The southwest portion of the barn is clad in corrugated metal panels. The remainder of the barn is clad in vertical boards. The exterior walls of the barn rest on either concrete block or poured concrete foundations. The interior vertical support members rest on replacement poured concrete piers. An original stone pier is visible in the middle portion of the barn. The possible remnants of an old lane appear to be located along the west side of the tree line/fence row to the front of the barn extending in the direction of US 68 (Resource N) (Russellville Road). A house appears on or near the site of the foundation on the 1928 oil and gas map (Figure 24). The house and the barn are depicted on the 1952 topographic map (Figure 25).

Figure 72. Site 3, Livestock barn (Resource M) looking to the northeast.

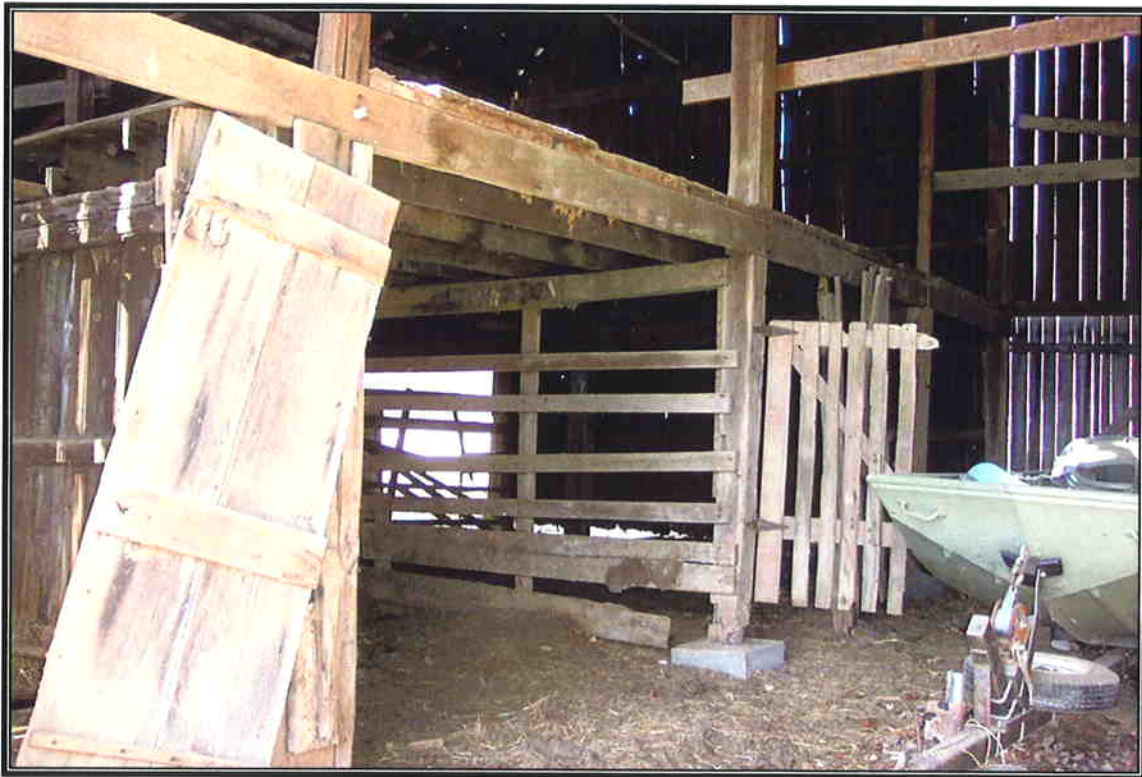
Figure 73. Site 3, Interior framing of barn.

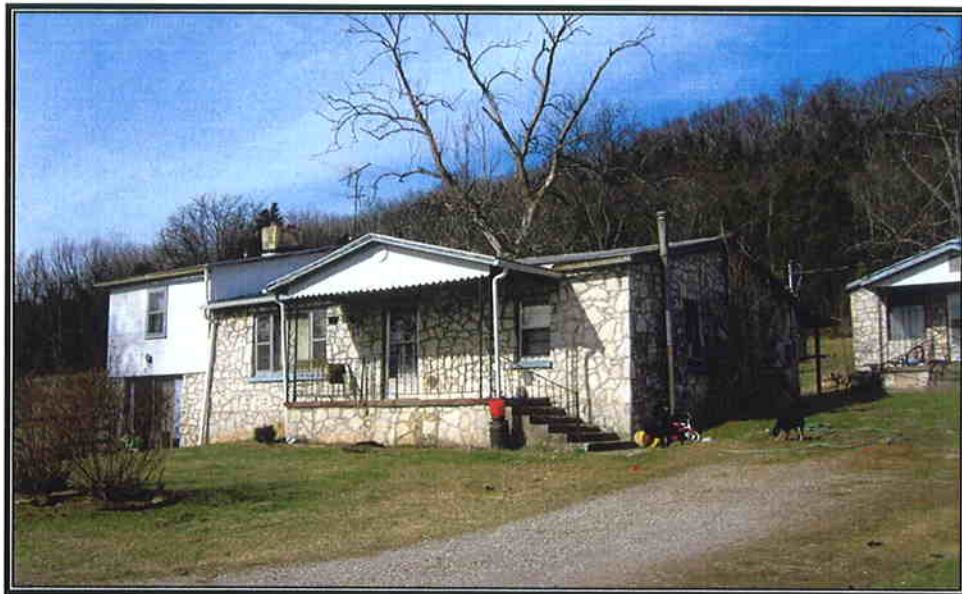
The lane leading to the prior house foundation curves to the southwest and then to the northwest before its terminus at two residences constructed of similar materials in close proximity to one another. The first house is a one-story, three-bay (w/d/w), side-gable house with a rubble stone exterior and a probable addition (Resource O) (Figure 74). The residence, which is similar in form to a Ranch house, is oriented to the southeast. A gable-roof porch, supported by decorative metal posts resting on a poured concrete deck, shelters the single-leaf entry and window to the right of the entry. The entry has a multi-light door. The window to the right of the entry has horizontal two-over-two double-hung sashes. The majority of the windows in the house have the same type of sashes. The picture window to the left of the entry has two-over-two double-hung sashes as sidelights. The northeast gable end elevation has two windows. The rear elevation has a shed-roof porch extending the width of the one-story portion of the house (Figure 75).

Figure 74. Site 3, One-story, three-bay, side-gable house with stone exterior (Resource O).

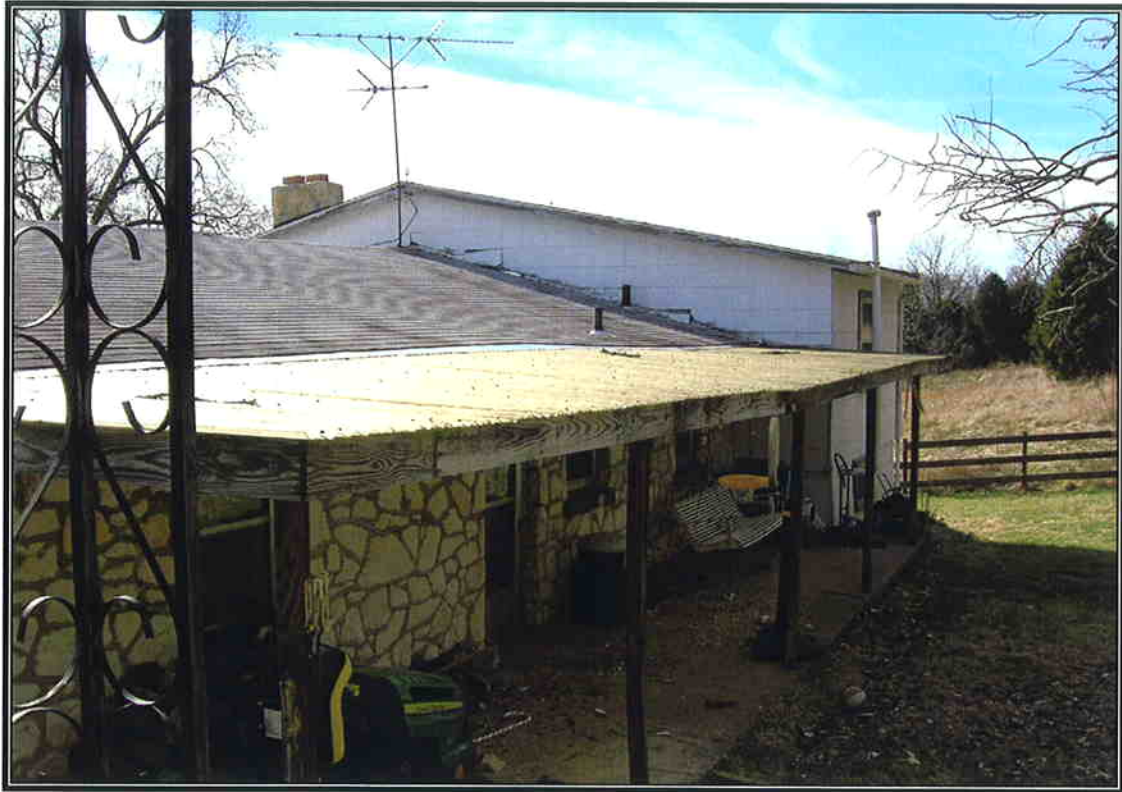
The porch is supported by square wood posts resting on a poured concrete deck. The porch roof appears to be a corrugated plastic material. The rear elevation has a single-leaf entry and three windows. The southwest elevation of the house has a one-story frame

Figure 75. Site 3, Rear elevation of house.

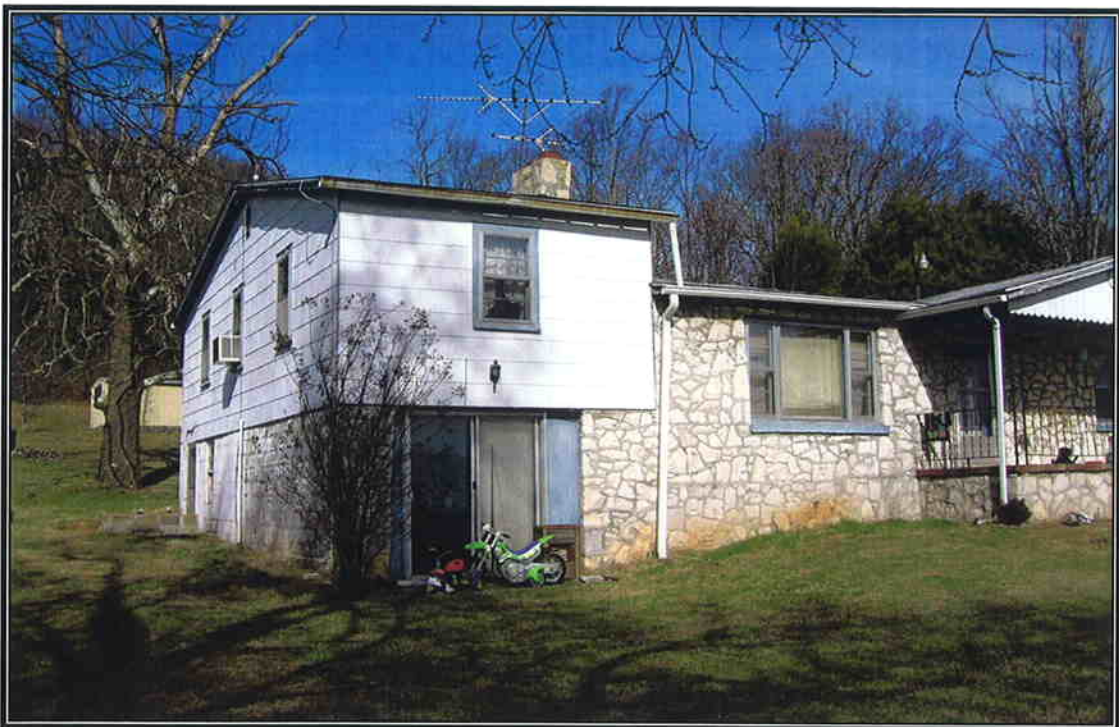
portion resting on a walk-out basement (Figure 76). This appears to be a later addition to the house. The basement façade of the addition has a rubble stone exterior and what may have originally been a garage entry. This entry has been filled with single-light horizontal sliding patio doors and possibly wood to the sides of the door frame. The rear and southwest elevations of the basement are constructed of concrete block. An exterior single-leaf basement entry is located near the rear of the house on the southwest elevation. The window sashes of the addition are the same as found throughout the house. The upper story of the addition is clad in asbestos shingles. A stone chimney pierces the front roof slope of the addition. The roof is sheathed in asphalt shingles. The majority of the stone exterior has grapevine mortar joints, although portions have been repointed or repaired and no longer retain the earlier mortar joints. The stone continues to grade and the foundation material could not be determined. A second house is located to the northeast and adjacent to the previous house. This is a one-story, three-bay (w/d/w), front-gable residence with a stone exterior constructed with grapevine mortar joints (Resource P) (Figure 77).

Figure 76. Site 3, Façade and southwest elevations of house.

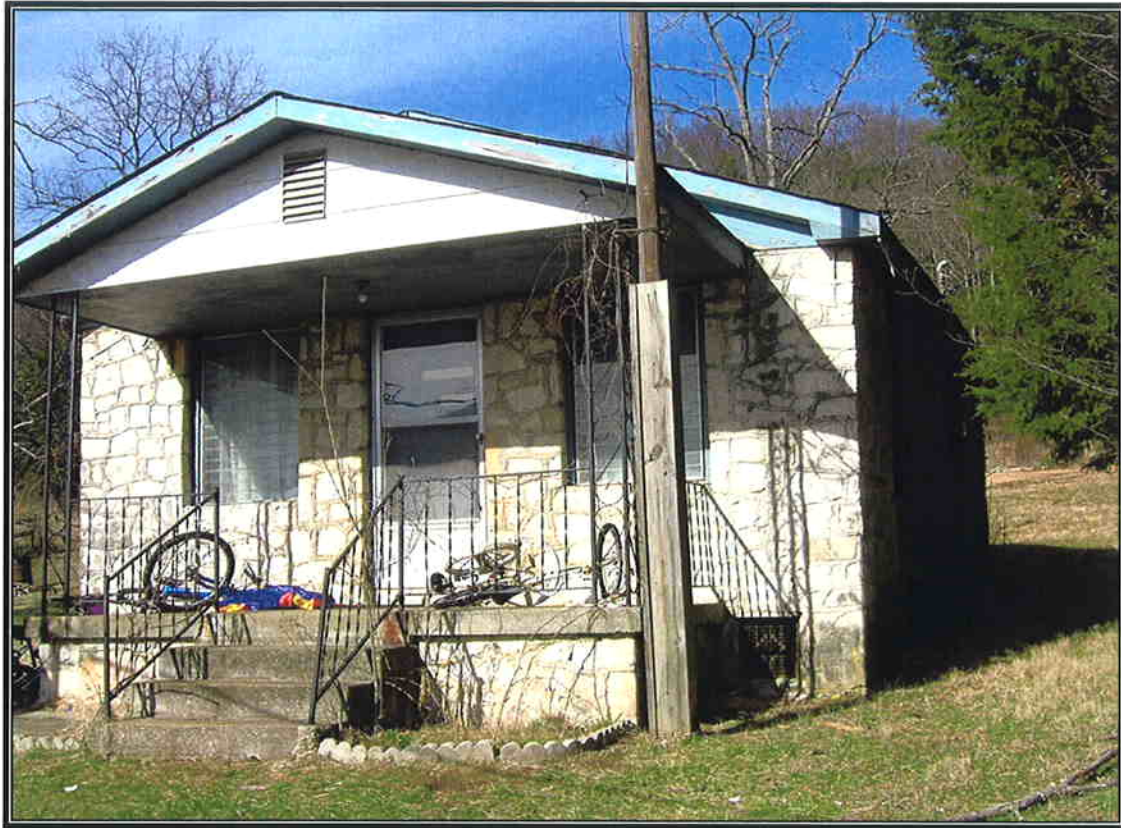
**Figure 77. Site 3, One-story, three-bay, front-gable house with stone exterior (Resource P).**

The house is oriented to the southeast. A gable-roof porch, extending over the three façade bays, is supported by decorative metal posts resting on a poured concrete deck. The porch also has a metal railing. The centered entry has a three-light door. The windows flanking the entry have adjustable glass louvers which may not date to the construction of the house. The southwest elevation has three windows with either six-over-six or horizontal two-over-two double-hung sashes (Figure 78). The rear elevation has a single-leaf entry sheltered by a gable-roof porch supported by wood brackets. To the left of the rear entry is a window with adjustable glass louvers. The roof is sheathed in asphalt shingles. The foundation material could not be determined as the stone exterior continues to grade. A large transverse crib livestock barn is located to the south of the previous two residences (Resource Q) (Figure 79).

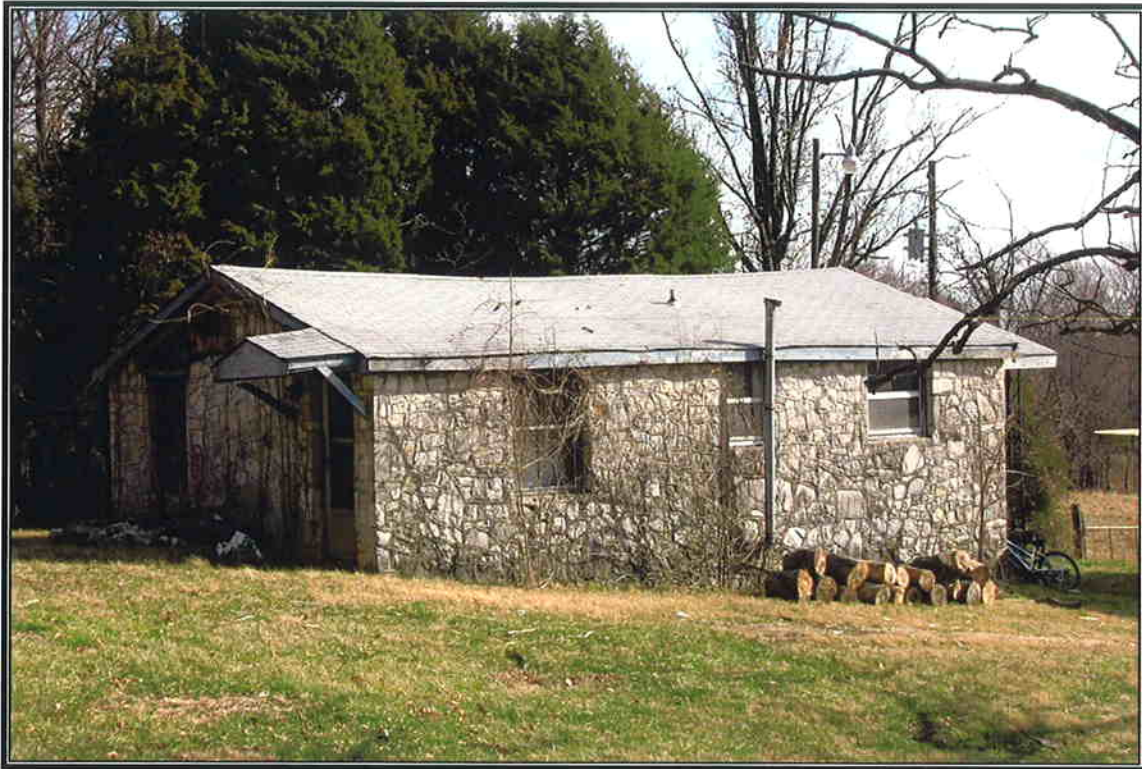
Figure 78. Site 3, Southwest and rear elevations of house.

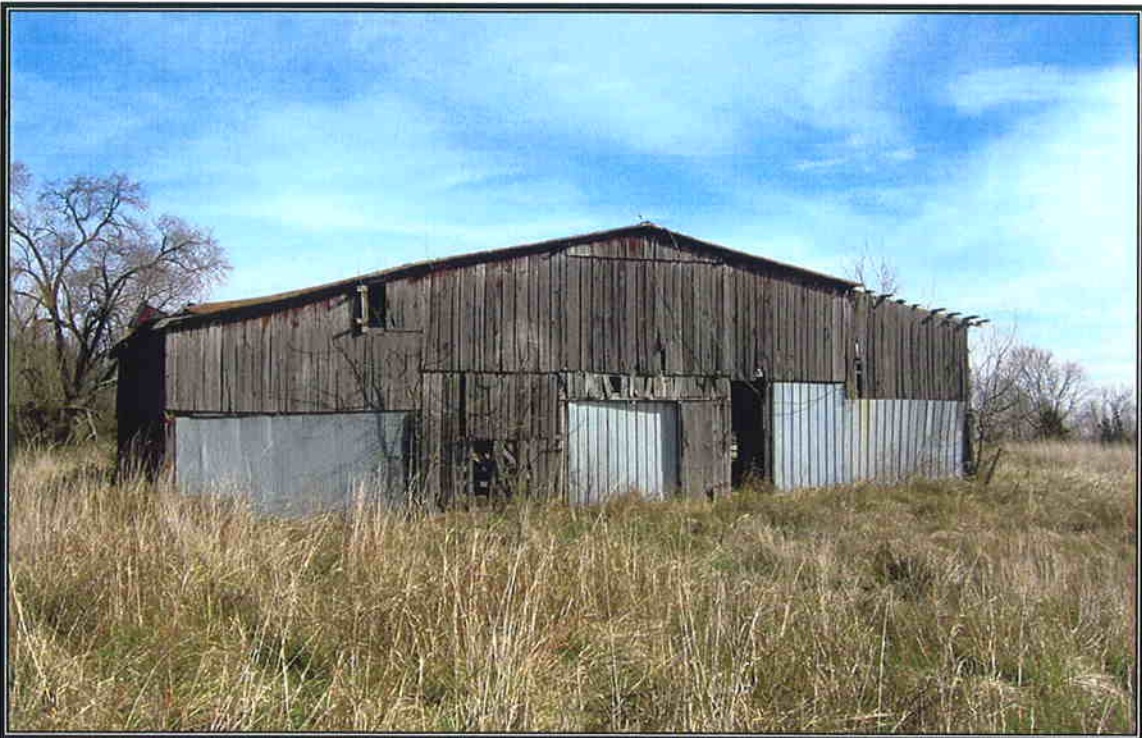
The construction of the barn is much like a pole barn, with tree trunks and sawn lumber serving as vertical and horizontal members (Figure 80). The roof of the barn is sheathed in metal. The barn is clad in vertical boards and rests on a poured concrete foundation. A small, three-bay (w/d/w), side-gable, frame outbuilding is located to the west of the barn adjacent to a pond (Resource R) (Figure 81). The façade has a centered single-leaf entry flanked by windows with two-over-single double-hung sashes. The door is leaning against an interior wall. No lights remain in the sashes. The interior walls are sheathed in bead boards. The outbuilding has exposed rafter tails. The roof, which is partially in ruinous condition, is sheathed in asphalt shingles (Figure 82). Portions of the weatherboard siding are also missing. The outbuilding appears to rest on grade.

Figure 79. Site 3, Transverse crib livestock barn (Resource Q).
